SOLUTIA - 005

Re: 1631210006 -- St. Clair County
Solutia (Monsanto - W.G. Krummrich Plant)
ILD000802702
Log No. C-777
Received: September 2, 1997
RCRA Closure

**Foundation
Report**

FIGURE 1
SITE LOCATION MAP
W.G. KRUMMRICH PLANT, SAUGET, IL

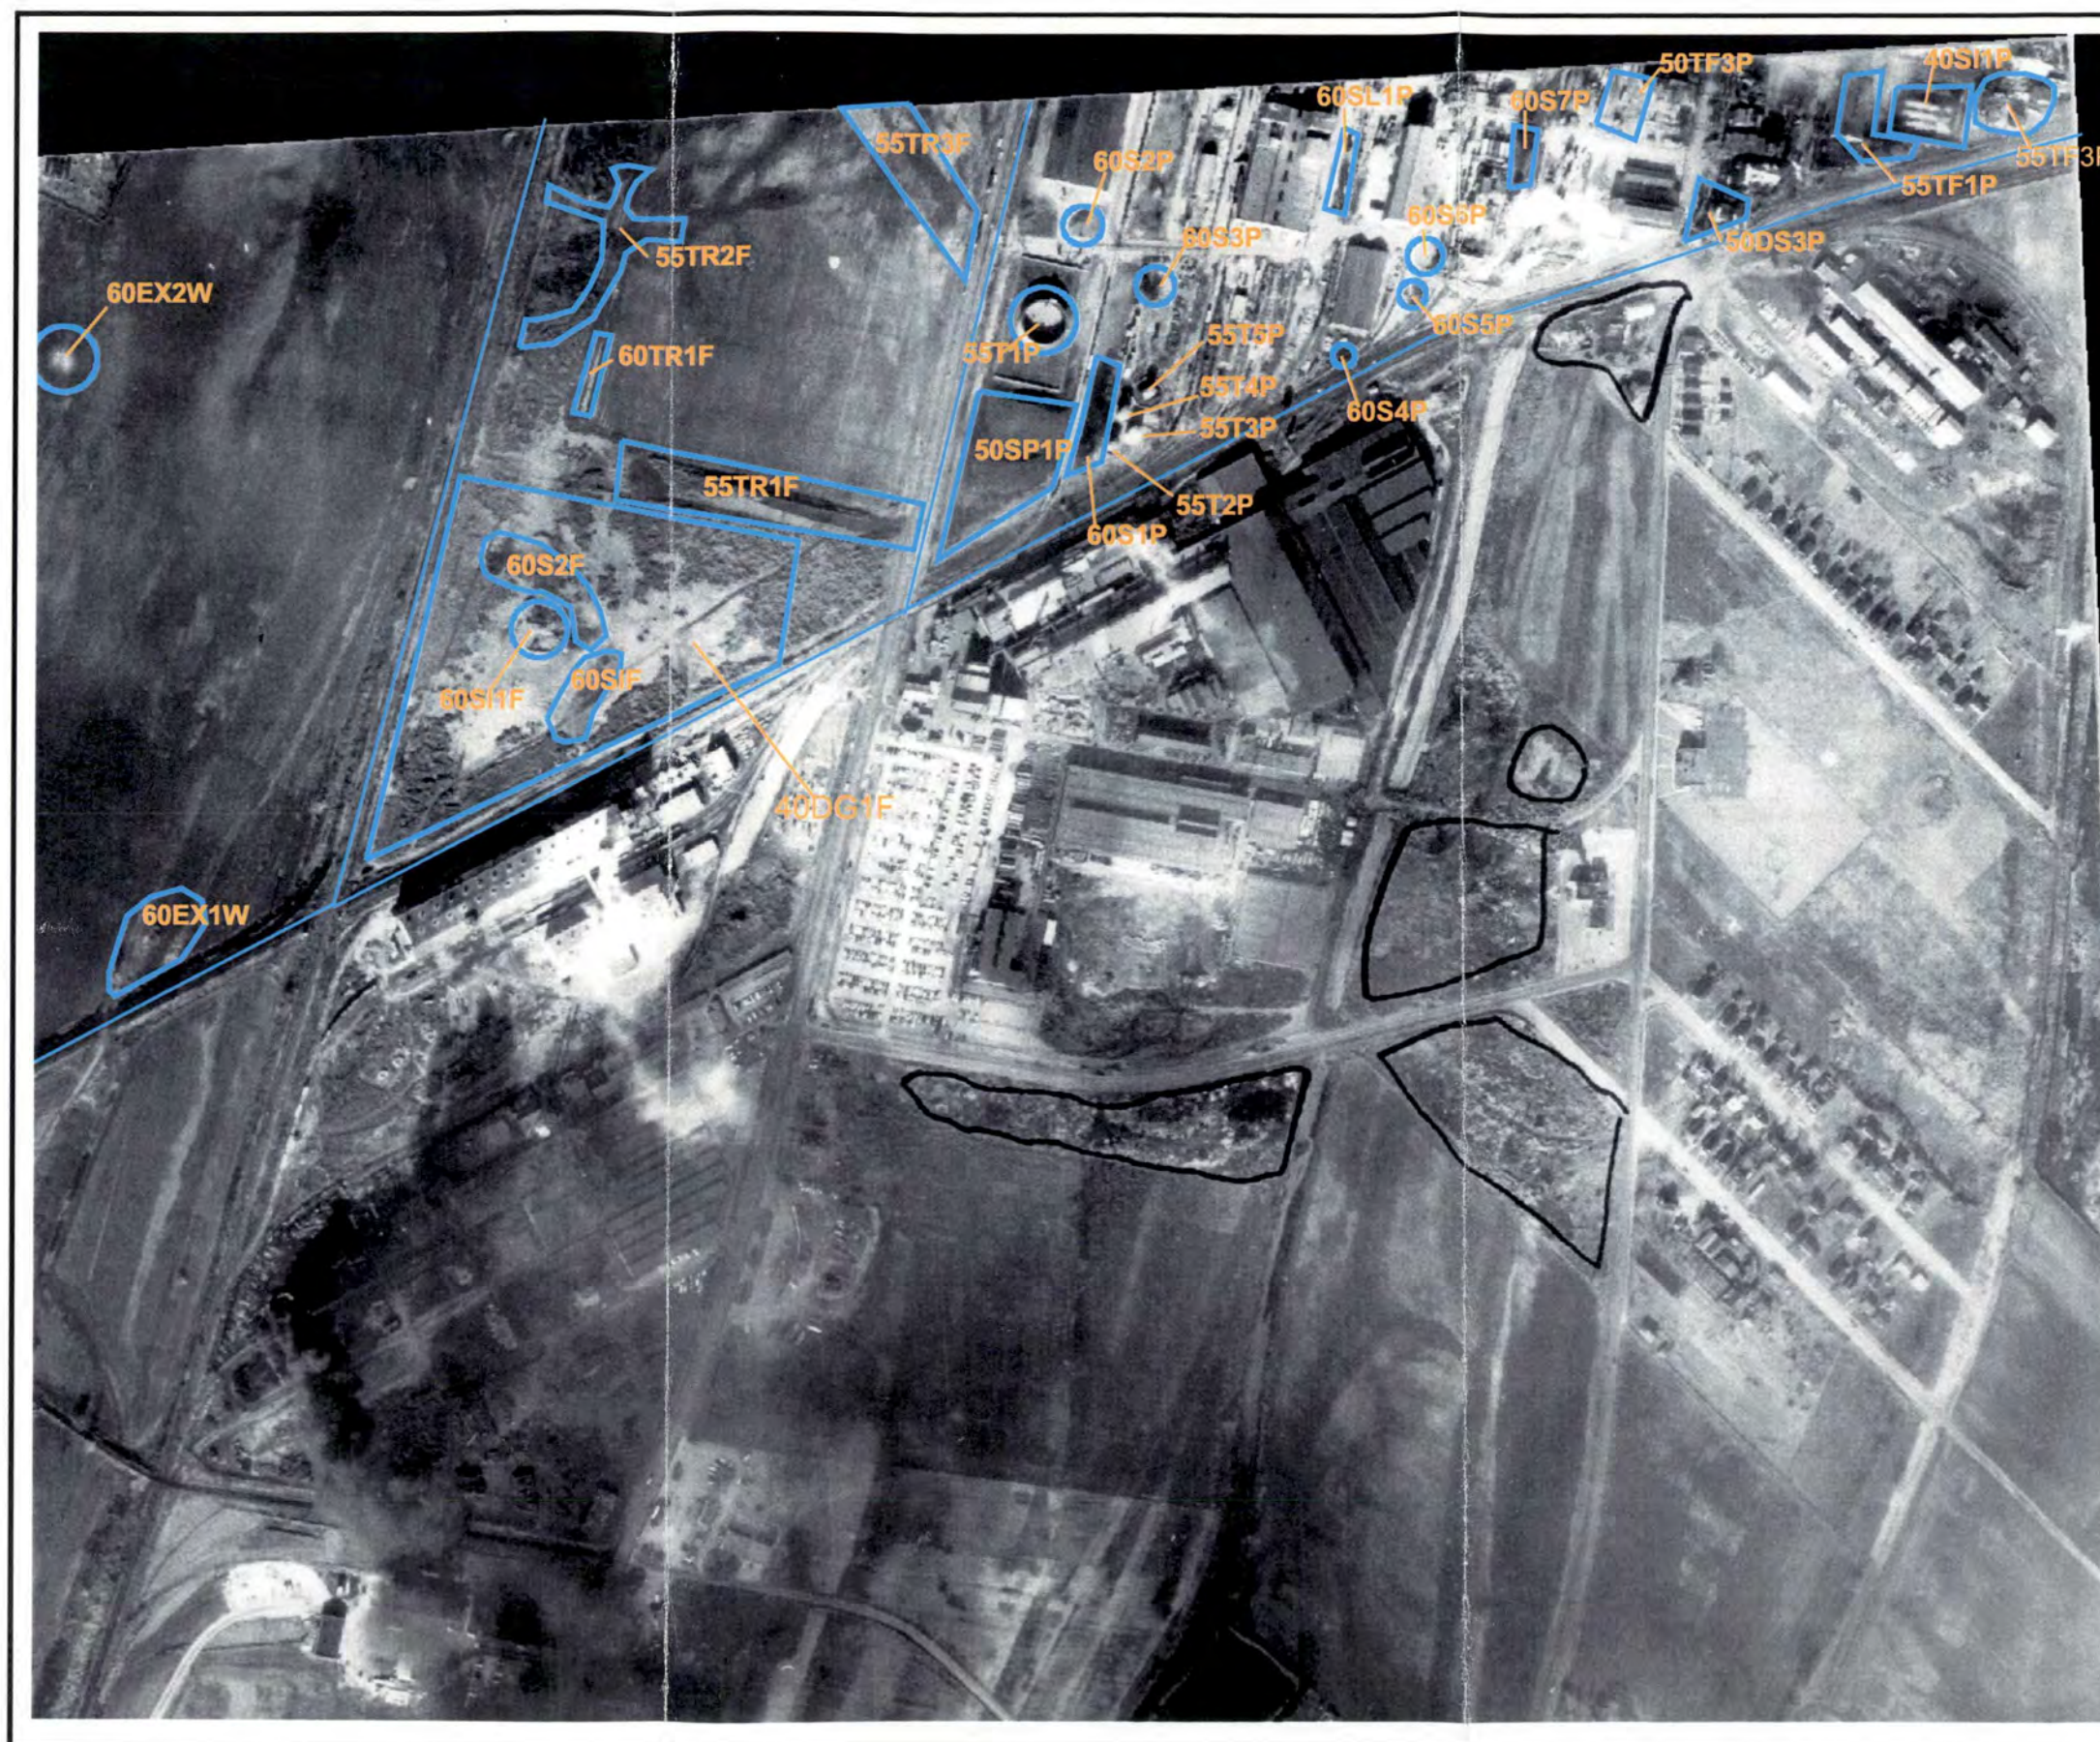
5

3.6 INTERPRETATION OF 1962 PHOTOGRAPH
